# Huff Creek Coordinated Resource Management Plan (CRMP)

## 2.0 Purpose of the Plan

The purpose of the coordinated resource management plan (CRMP) is to identify resource concerns and conservation opportunities in the Huff Creek Watershed and to develop planning objectives and feasible conservation actions. The plan presents solutions that, when implemented, will achieve the vision and goals of the CRMP Steering Committee, the Summit Conservation District and the local landowners. The CRMP will be the guidance document for developing conservation plans. The CRMP can be used to apply for funding through a variety of federal, state, and local programs to implement the planned conservation actions.

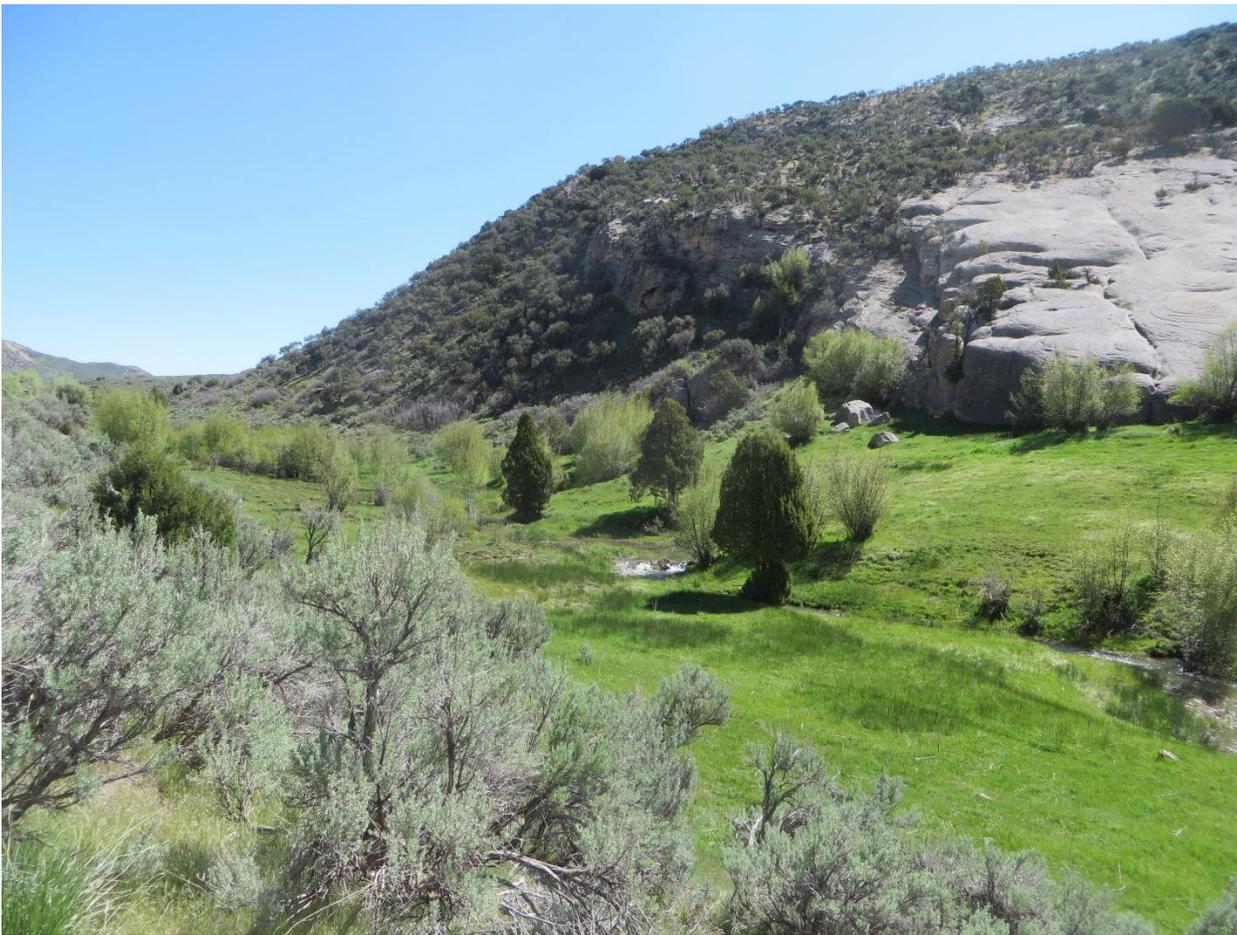
*Mid-Huff Creek – Note new flood plain forming along with desirable woody species achieved with time control of grazing*

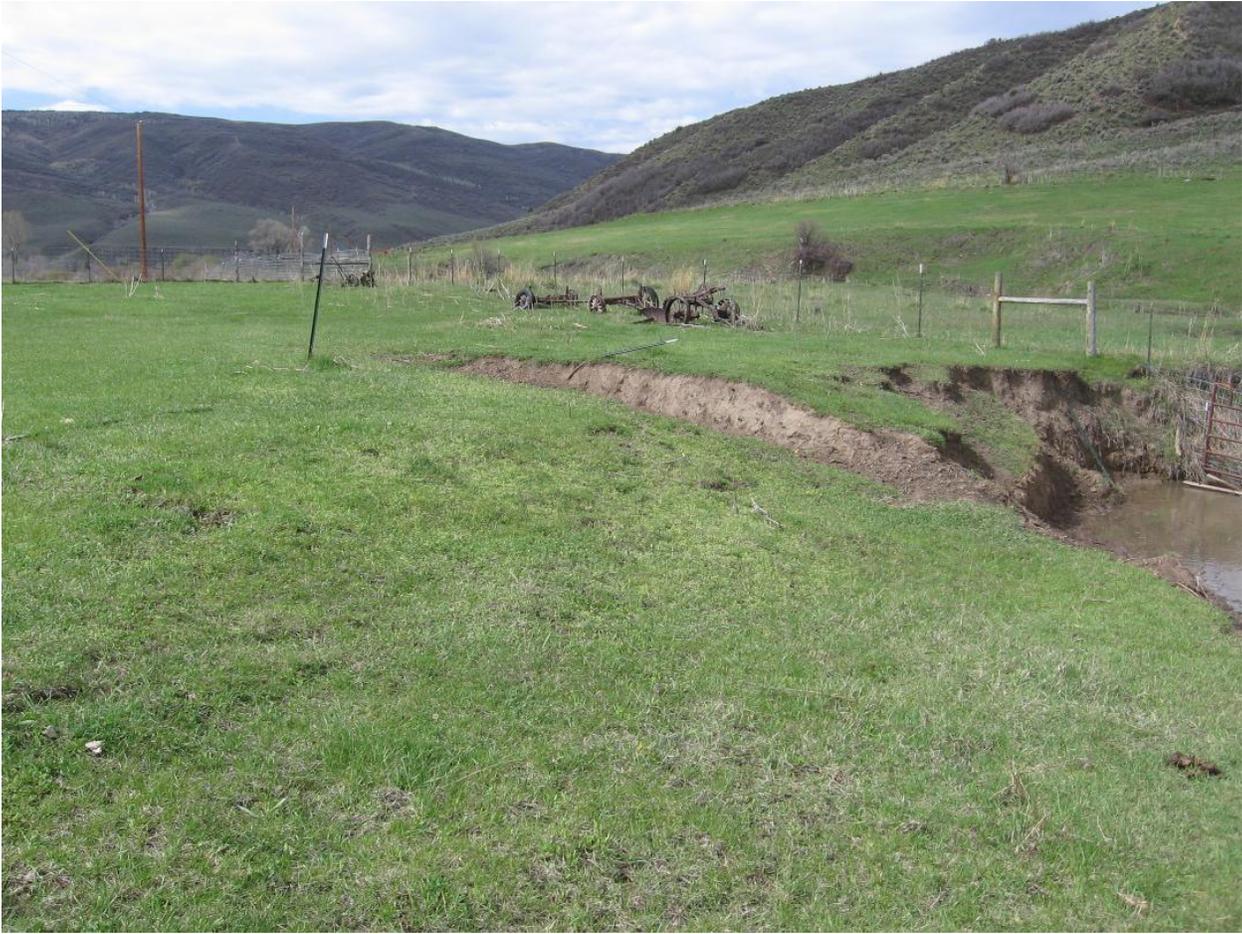
*Riparian Area on Huff Creek before fencing*

In June of 2016 an SVAP2 (Stream Visual Assessment Protocol) was conducted by the Summit Conservation District, NRCS and UDWQ on Huff Creek to assess stream conditions. SVAP is a multifaceted assessment tool used to provide a snapshot of current stream conditions. The watershed measures approximately 12 miles from its headwaters on Porcupine Mountain to the streams confluence with Chalk Creek. Conditions on the entire stream was assessed. Two of the elements scored on the SVAP are riparian quality and quantity. Based on the data collected from the SVAP approximately 15,654 ft. (3 miles) or 25% of Huff Creek was scored as either severely degraded or in poor condition based on the riparian quantity and quality scores. Streamside management practices such as willow eradication have contributed to degraded riparian conditions resulting in a loss of stream vegetative cover, unstable bank conditions and sediment inputs.

Changes in riparian management practices would result in improved conditions on Huff Creek. Some implementation practices to consider would be stock water development off of the stream out of the riparian area. In addition, limiting or controlling grazing access with riparian fencing would be highly beneficial. Doing this would be very beneficial as livestock currently have uncontrolled access to much of the stream over the summer grazing period, and in some areas year-round. Developing better permanent fish friendly irrigation diversion structures to facilitate improved irrigation, improve fish passage, and reduce washouts and sediment inputs during high water could benefit areas lower down in the watershed where irrigation water is being diverted from Huff Creek. A new tool that could be beneficial in certain areas where riparian degradation has occurred would be the installation of BDA's (Beaver Dam Analog) structures. These structures mimic natural beaver dams. Installing these types of structures in incised areas of Huff Creek could help to slow stream velocities, capture sediment and build streambeds back up and raise water tables. This practice coupled with selective willow plantings could help to restore historic riparian conditions that once prevailed on Huff Creek.

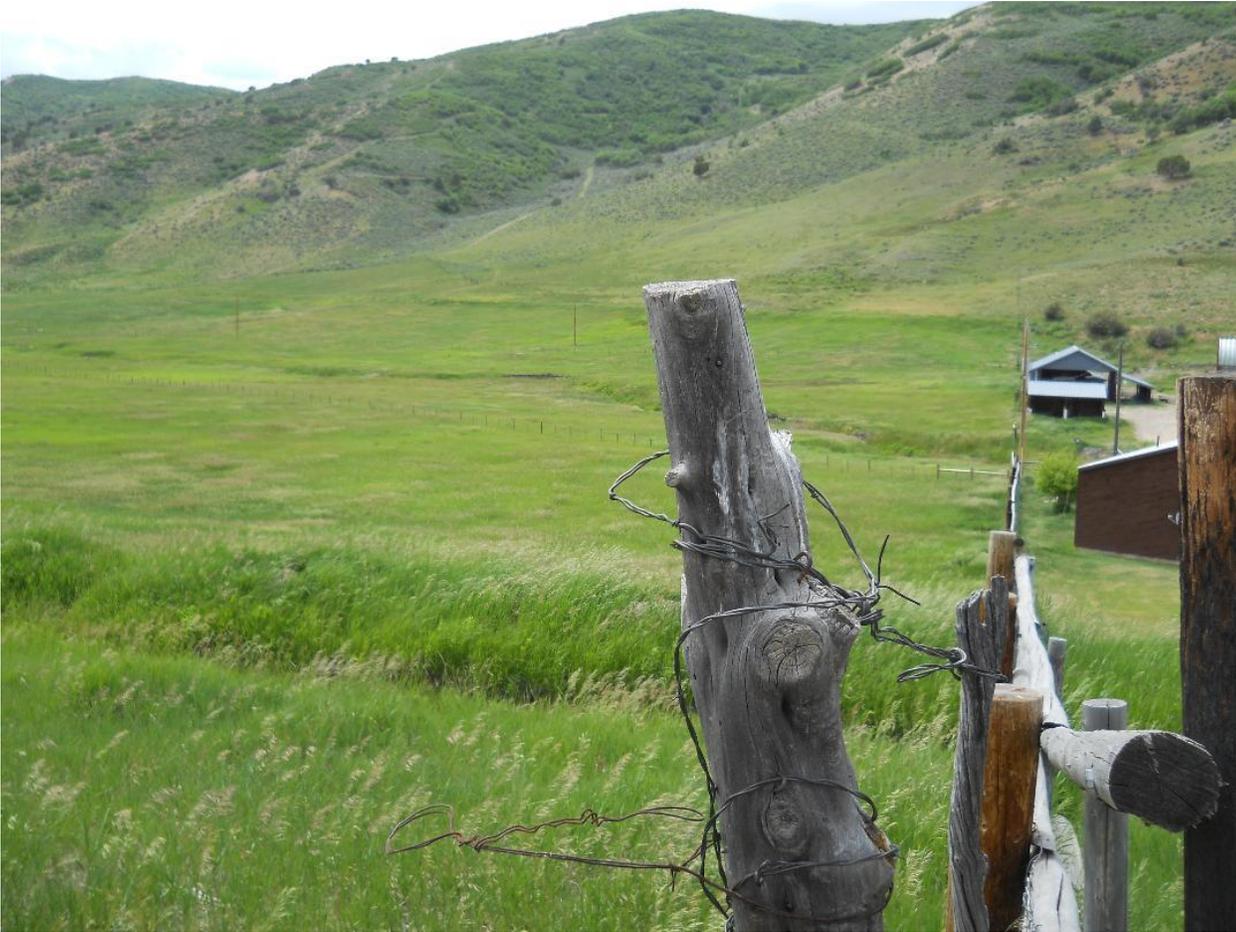
*Riparian Area on Huff Creek After fencing – note healing of riparian zone*

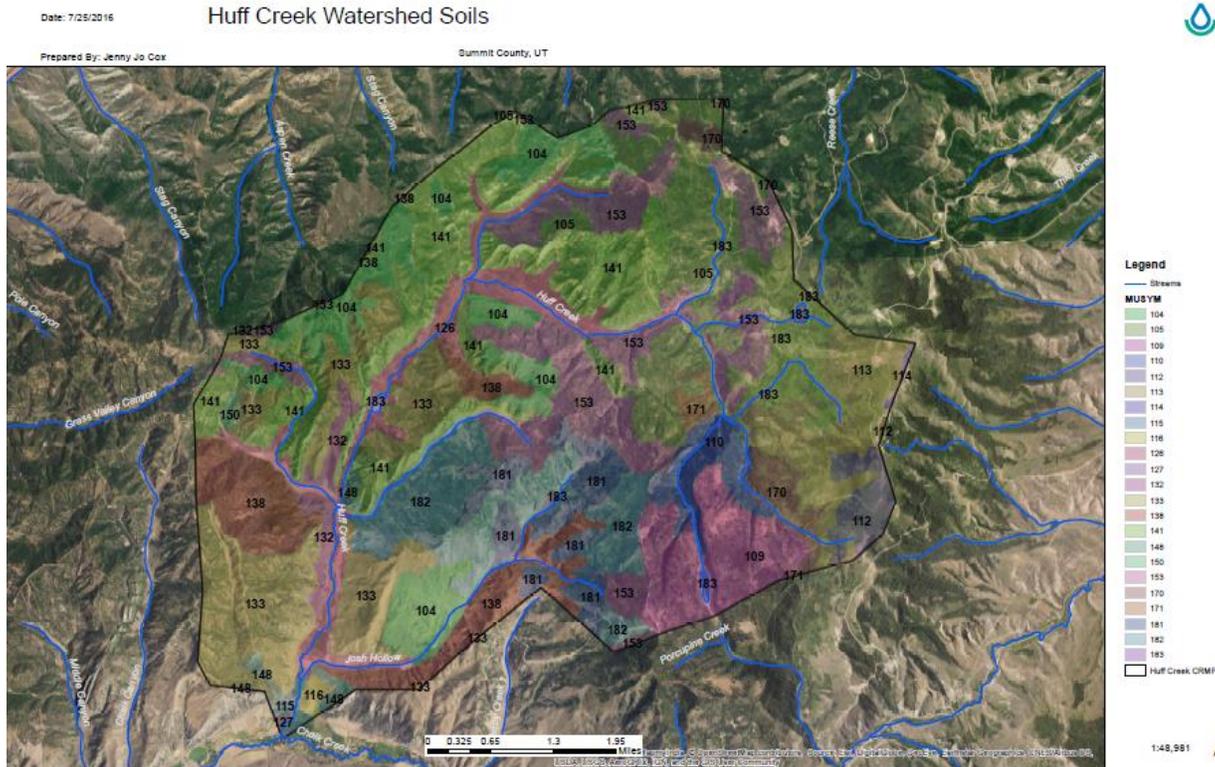
There are 23 different soil types in the watershed. Most are Loams.

The most dominate soil type (approximately 40% of the watershed) are the Fewkes soil complexes. Fewkes soils are clay loams occurring on up to 60% slopes; Mountain Big sagebrush is the common ecological site for this soil. These are well drained soils that don't flood or pond. Their parent material is derived from sandstone, quartzite and shale.

Another soil of interest occurs on the stream terraces associated with riparian areas. Soil 126 Echocreek loam occurs on 2-10 % slopes and is associated with Basin Wildrye Ecological Type. This soil is alluvial from sandstone, quartzite and shale. It is considered prime farmland when irrigated due to its well-developed horizons. These are well drained soils with a low runoff classification. This soil has a high available water storage profile, hence was historically a floodplain.

For a complete soil and ecological site description for the Huff Creek Watershed refer to the NRCS Huff Creek Watershed Soil Report in the appendix.

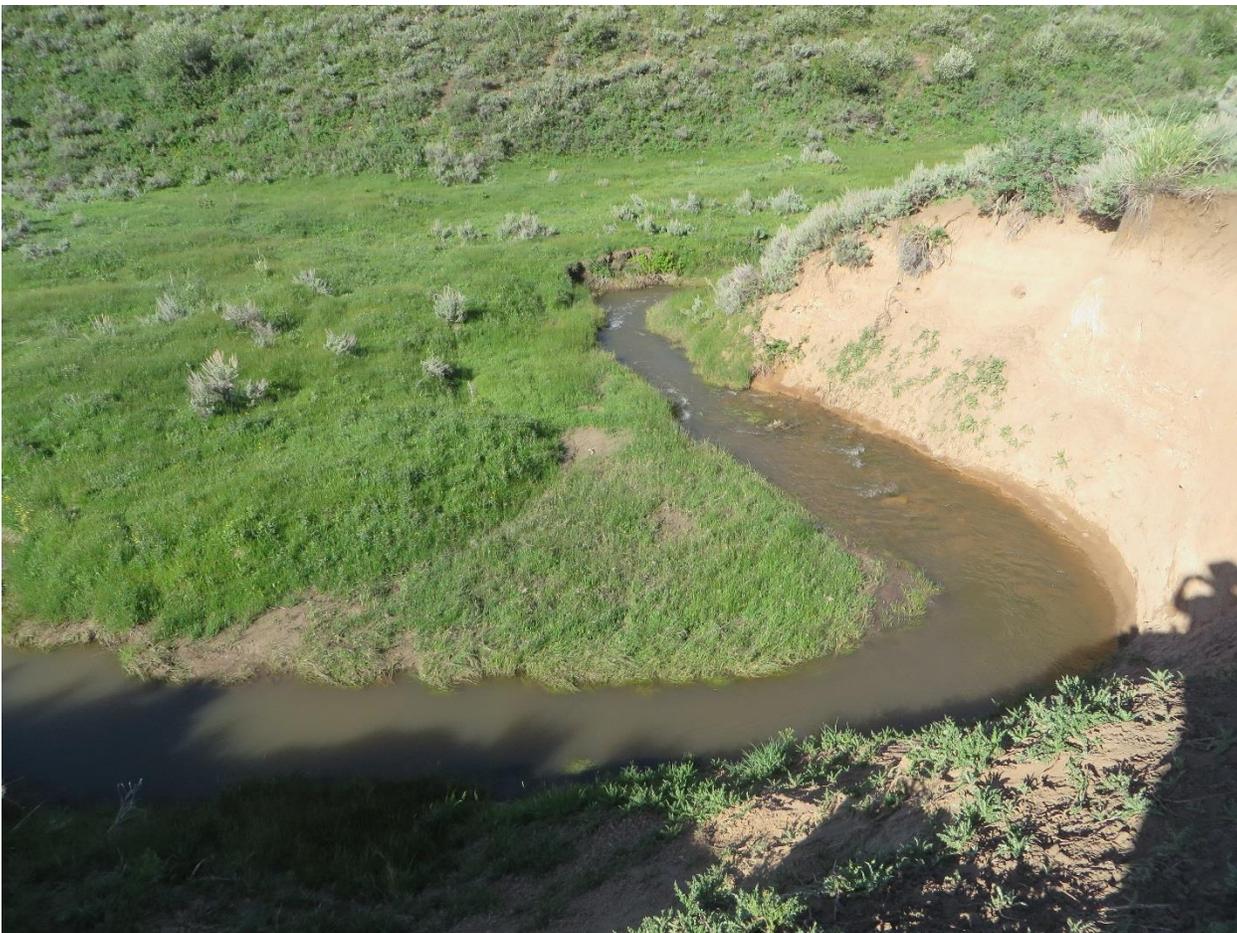
*Photo along upper Huff Creek – note point bar attempting to re-establishing sedges and grasses along with new flood plain.*
